MEMORANDUM ASBESTOS SURVEY FINAL REPORT CNC CHARLESTON SC
3/1/1998
ENVIRONMENTAL DETACHMENT CHARLESTON

Subj: **ASBESTOS SURVEY FINAL REPORT, Charleston Naval Base Housing**

NAVAL HOUSING CHARLESTON NAVAL BASE CHARLESTON, SOUTH CAROLINA

ASBESTOS INSPECTION REPORT

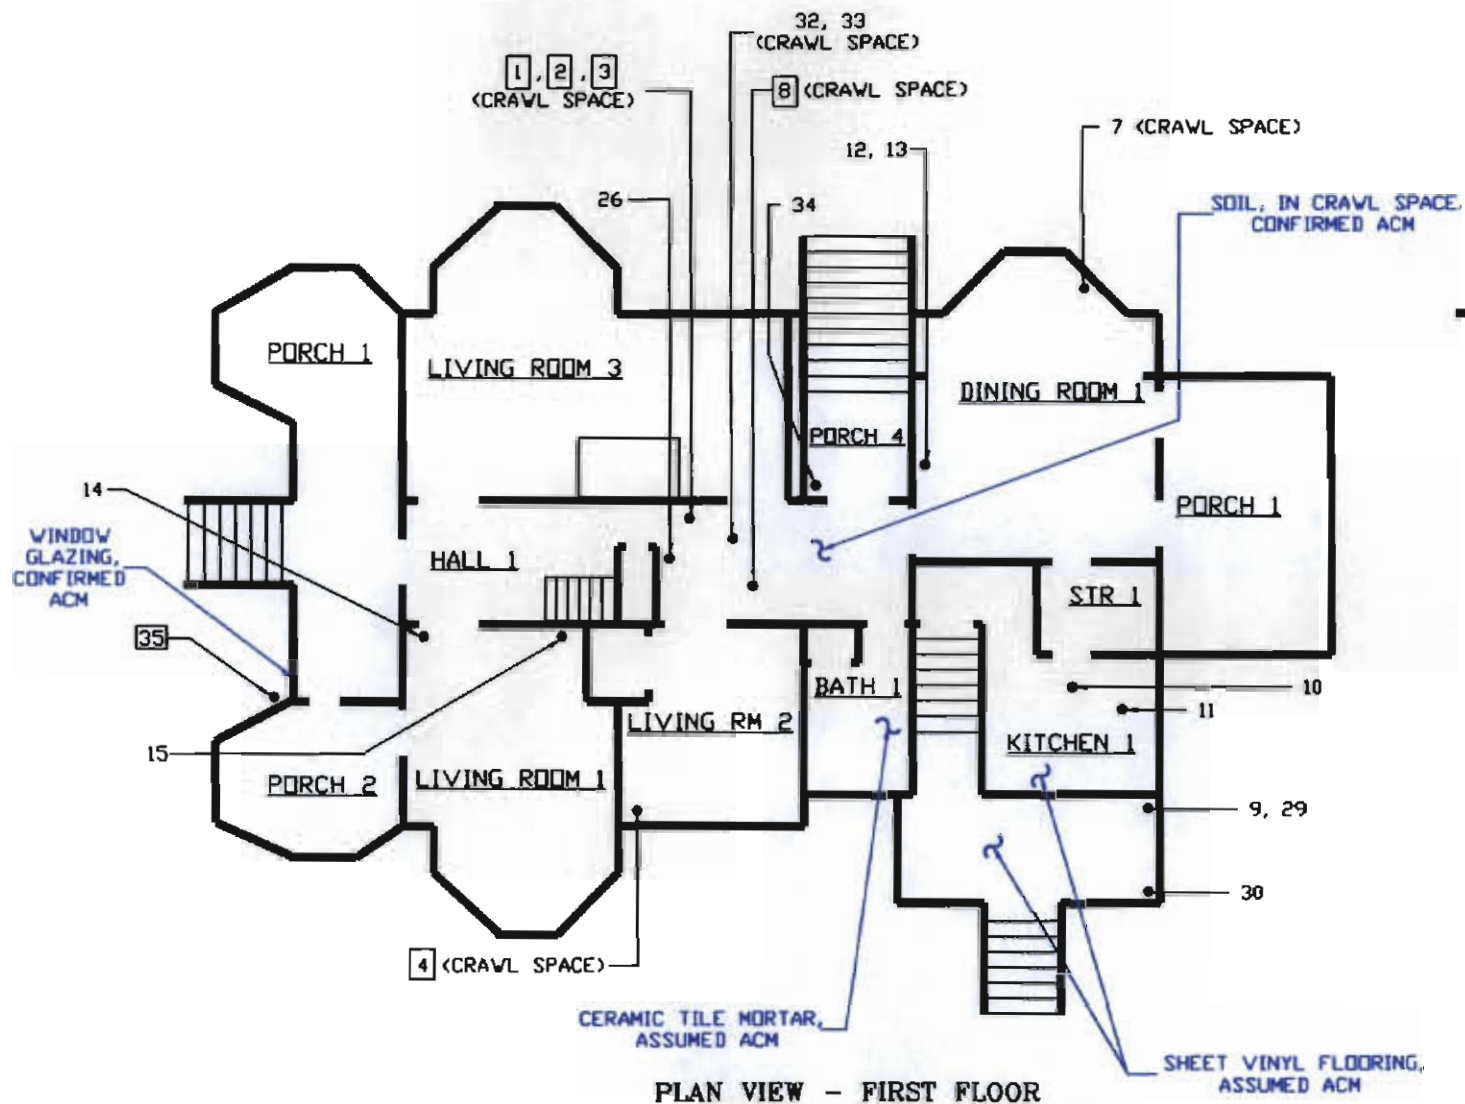
PLAN VIEW - FIRST FLOOR

Sample No.	ACM Y/N /A	Material Description / LOCATION	Quantity	AHERA CATEGORY	FRIABLE	Cond	% D	Recommended Action	Comments
ASSUMED	A	SHEET VINYL FLOORING, kitchen and storage	316 sq. ft.	8	N	G	0	O & M	This flooring was confirmed ACM in other housing units.
ASSUMED	A	MISC., CERAMIC TILE MORTAR, all bathrooms	577 sq. ft.	8	N	G	0	O & M	
99-NW-34 99-NW-35	N Y	MISC., EXTERIOR WINDOW GLAZING	*	*	*	*	*	*	assessment not required on exterior materials
99-NW-1 99-NW-2 99-NW-3 99-NW-4 99-NW-8	Y Y Y Y Y	SOIL., loose pieces of debris scattered throughout soil of crawl space	2160 sq ft	4	Y	D	100	Remove

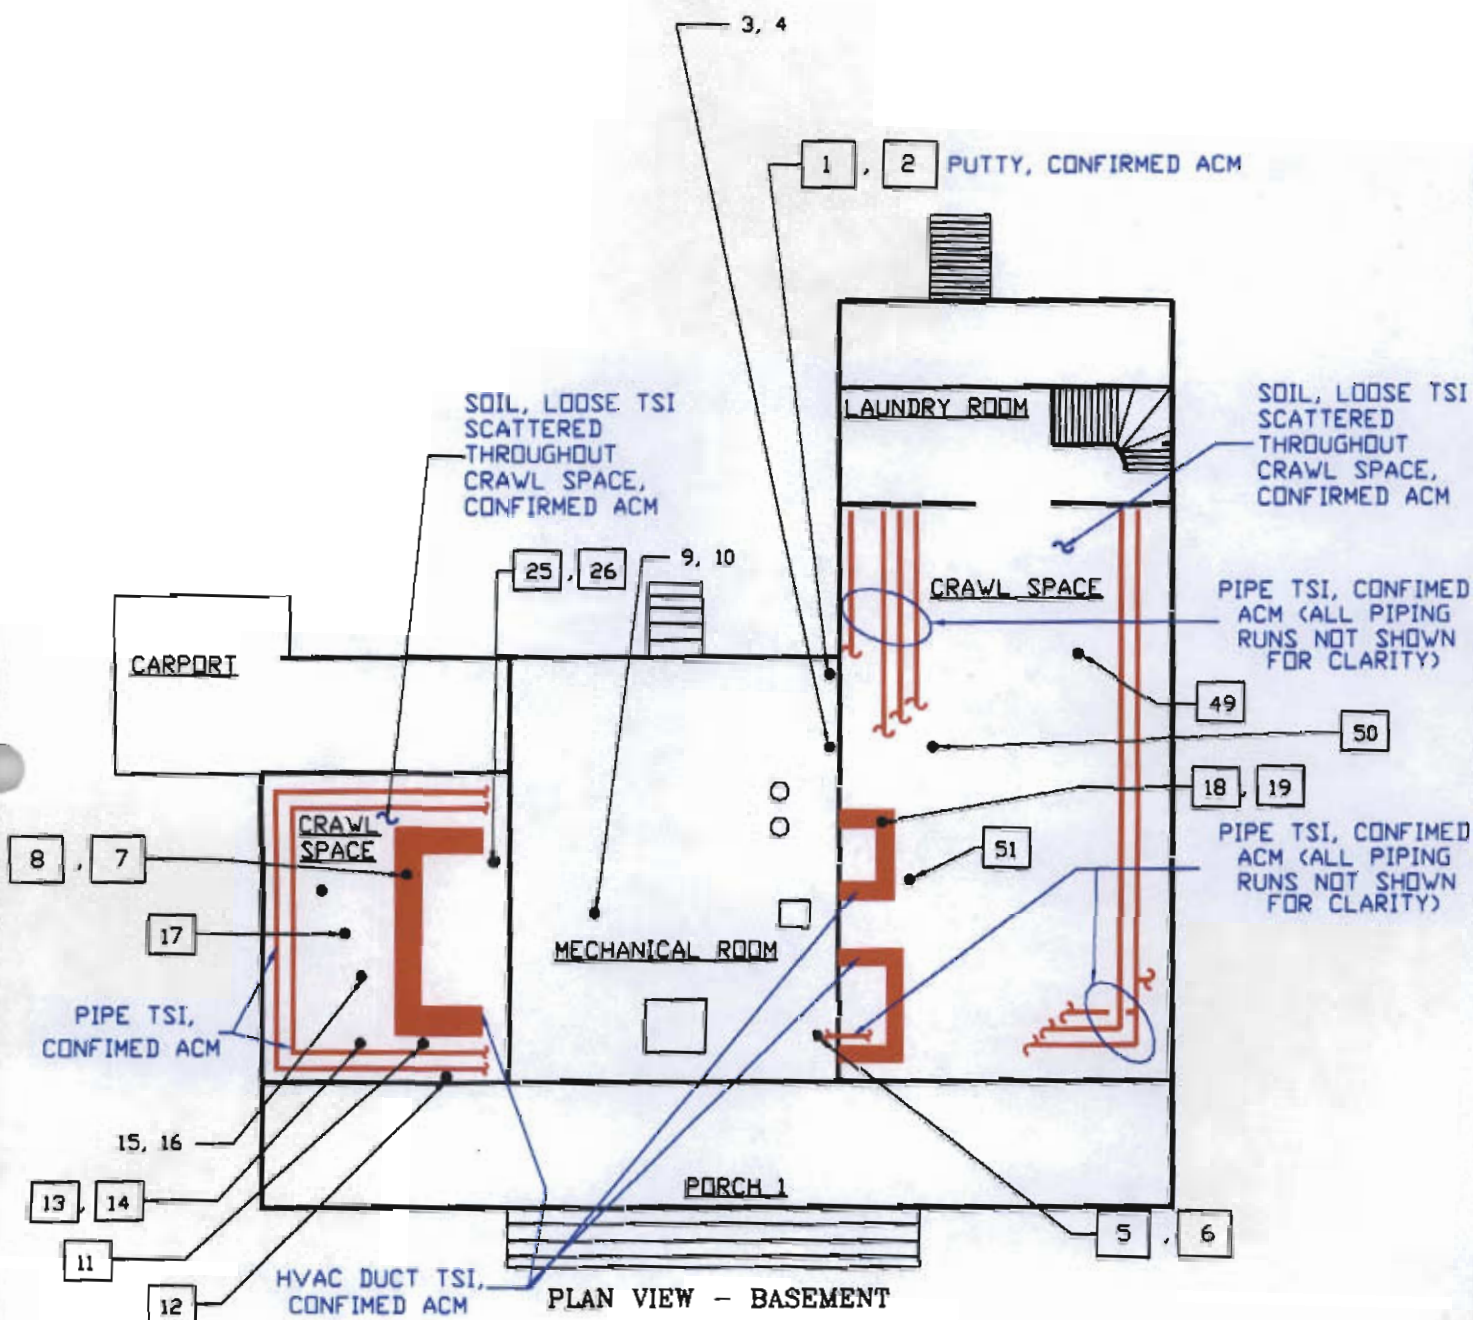
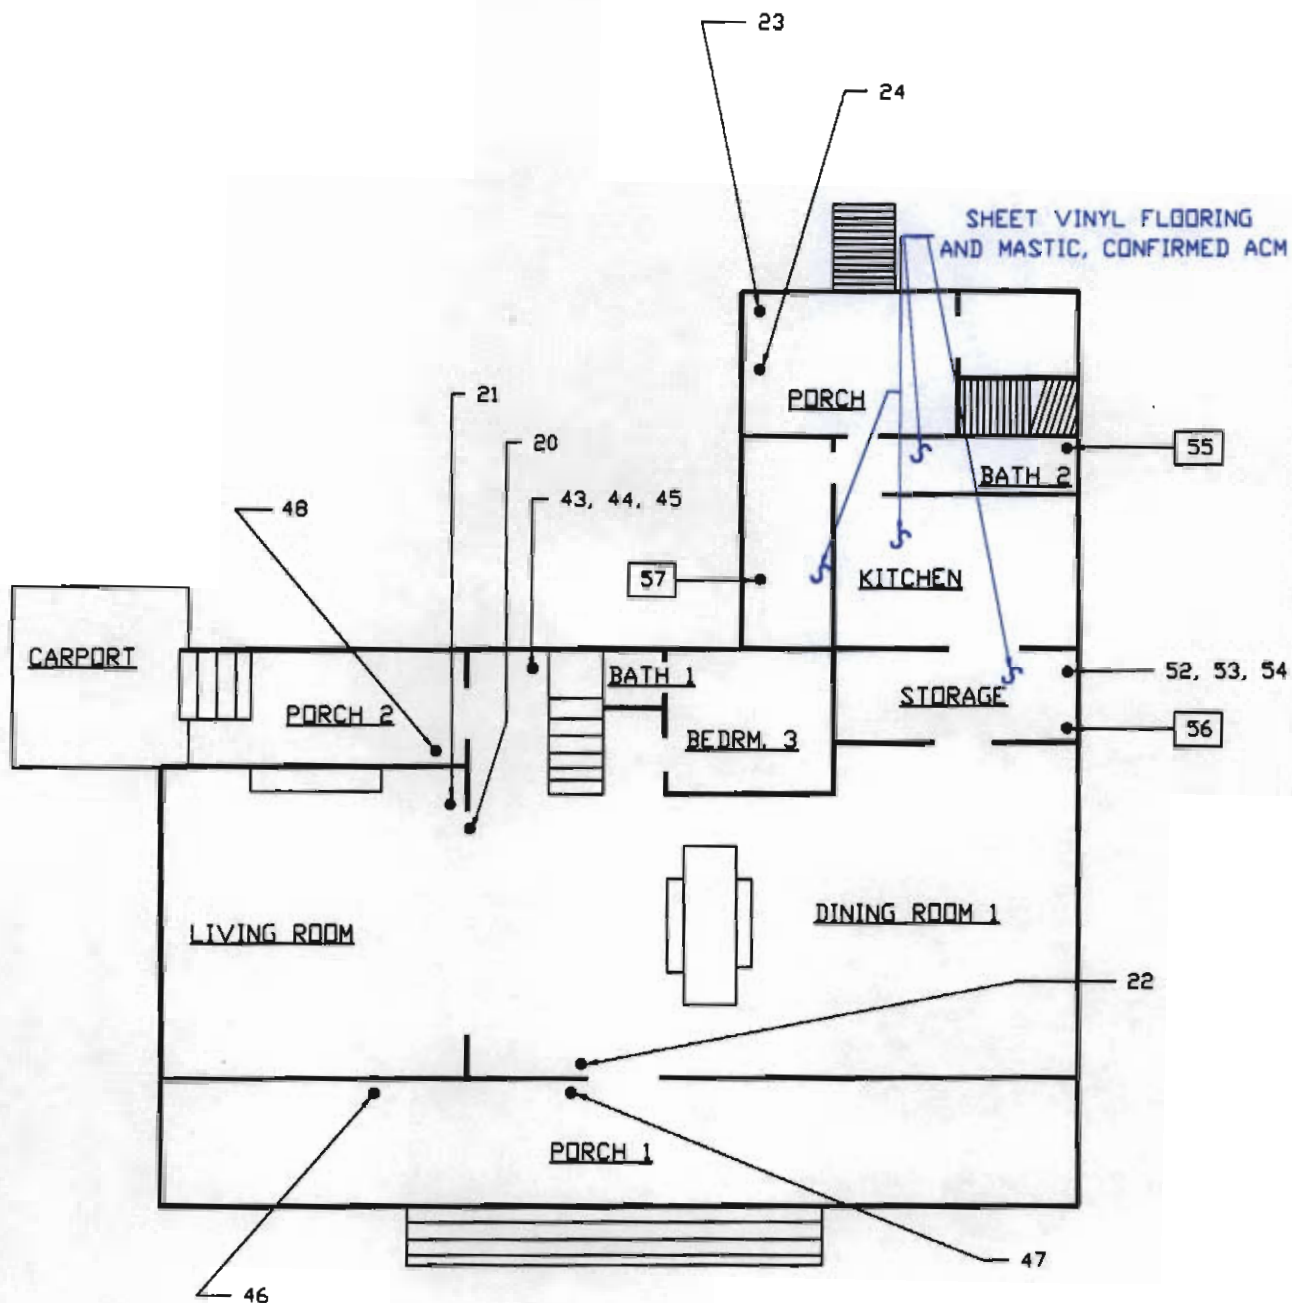
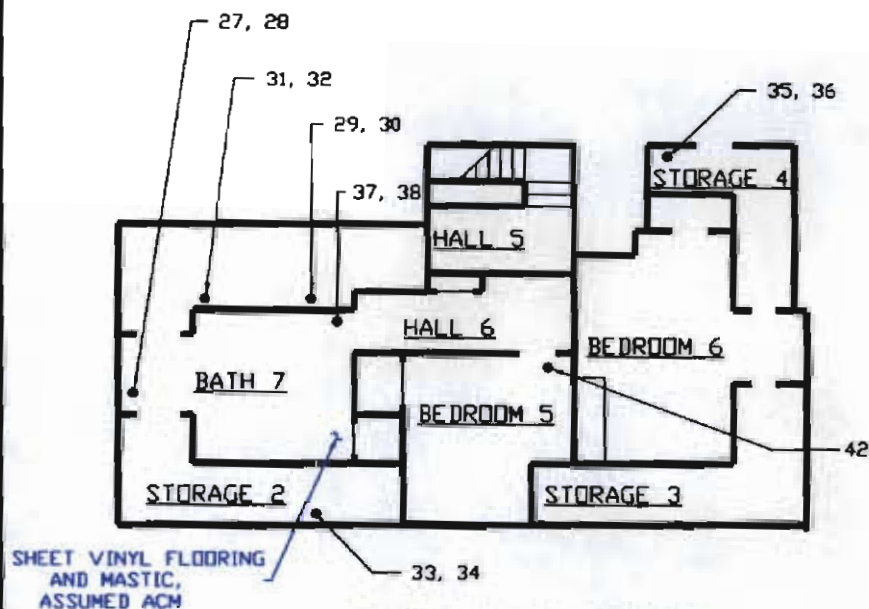
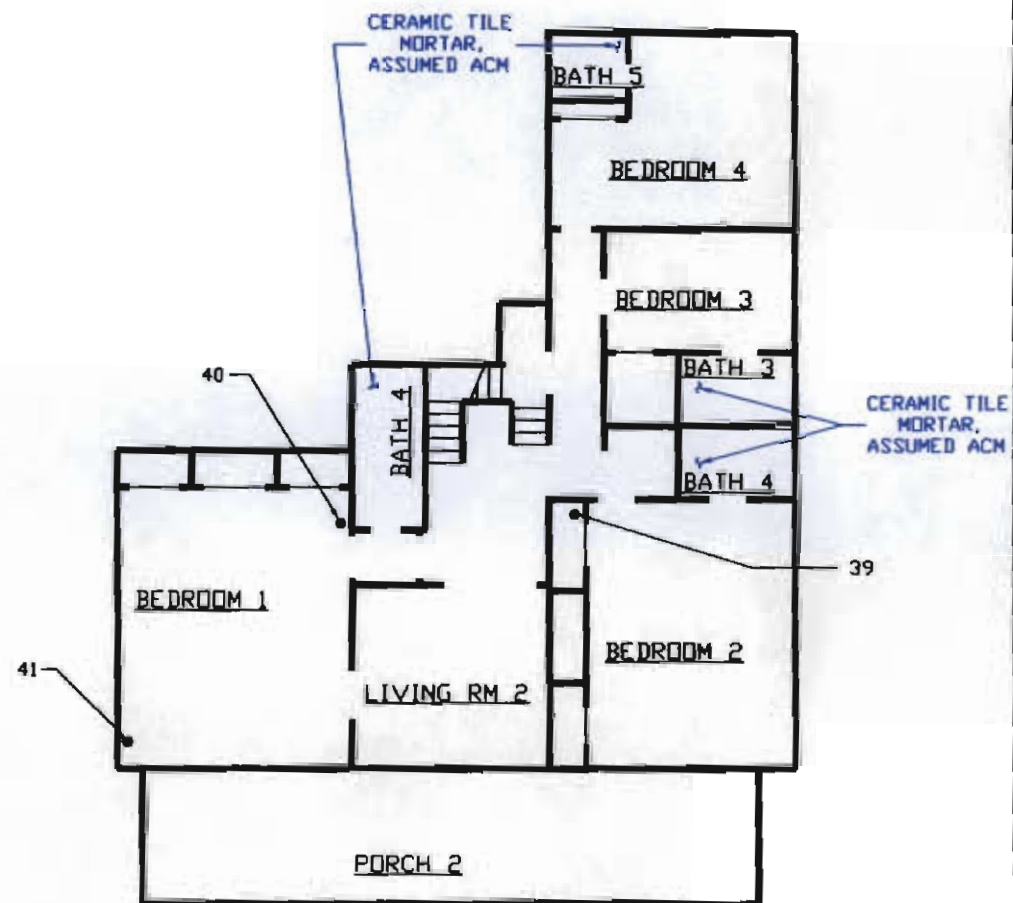
DWG NAME: ASB 100_1

1. PUTTY, used as packing between piping and wall in mechanical room
2. PIPING TSI, in mechanical room
3. PIPING TSI, in both crawl spaces
4. HVAC DUCT TSI, in both crawl spaces, some TSI has been removed from this duct but large remnants are still in place
5. SOIL, from crawl space, loose pieces of TSI scattered throughout both crawl spaces
6. SHEET VINYL FLOORING and MASTIC, kitchen and adjacent storage room, bathroom # 2 and # 7

Sample No.	ACM Y/N /A	Material Description / LOCATION	Quantity	AHERA CATEGORY	FRIABLE	Cond	% D	Recommended Action	Comments
100-NW-1 100-NW-2	Y Y	MISC., Putty / packing between piping and wall. Mach. Room / Basement	2 cubic ft.	4	Yes	SD	50	REMOVE	
100-NW-5 100-NW-6 100-NW-11 100-NW-12	Y Y Y Y	PIPING TSI, mechanical room and both crawl spaces	530 LF	1	Yes	SD	25	REMOVE	
100-NW-7 100-NW-8 100-NW-18 100-NW-19	Y Y Y Y	HVAC Duct TSI, in both crawl spaces	30 LF	1	Yes	SD	30	REMOVE	
100-NW-13 100-NW-14 100-NW-17 100-NW-25 100-NW-26 100-NW-49 100-NW-50 100-NW-51	Y Y Y Y Y Y Y Y	SOIL, loose pieces of TSI scattered throughout both crawl spaces	1482 sq. ft.	1	Yes	SD	100	REMOVE	
100-NW-55 100-NW-56 100-NW-57	Y Y Y	MISC., SHEET VINYL FLOORING, kitchen and storage, bathrooms # 2, and # 7	428 sq. ft.	6	YES, only where damaged	G	<1	REPAIR, O & M	flooring raised up and separating near sink in bathroom # 2
ASSUMED	A	MISC., CERAMIC TILE MORTAR, bathrooms 3, 4, 5, and 6	628 sq. ft.	8	NO	G	0	O & M
